**TITLE: CERTIFICATE OF APPROVAL OF HAWP-36G**

Applicants: Bob and Cathy Drzyzgula, Request for tree removal at 16 Walker Avenue

**INDEX OF MEMORANDA  
HAWP-36G**

# Tree Structure Evaluation Field Data Collecting Form

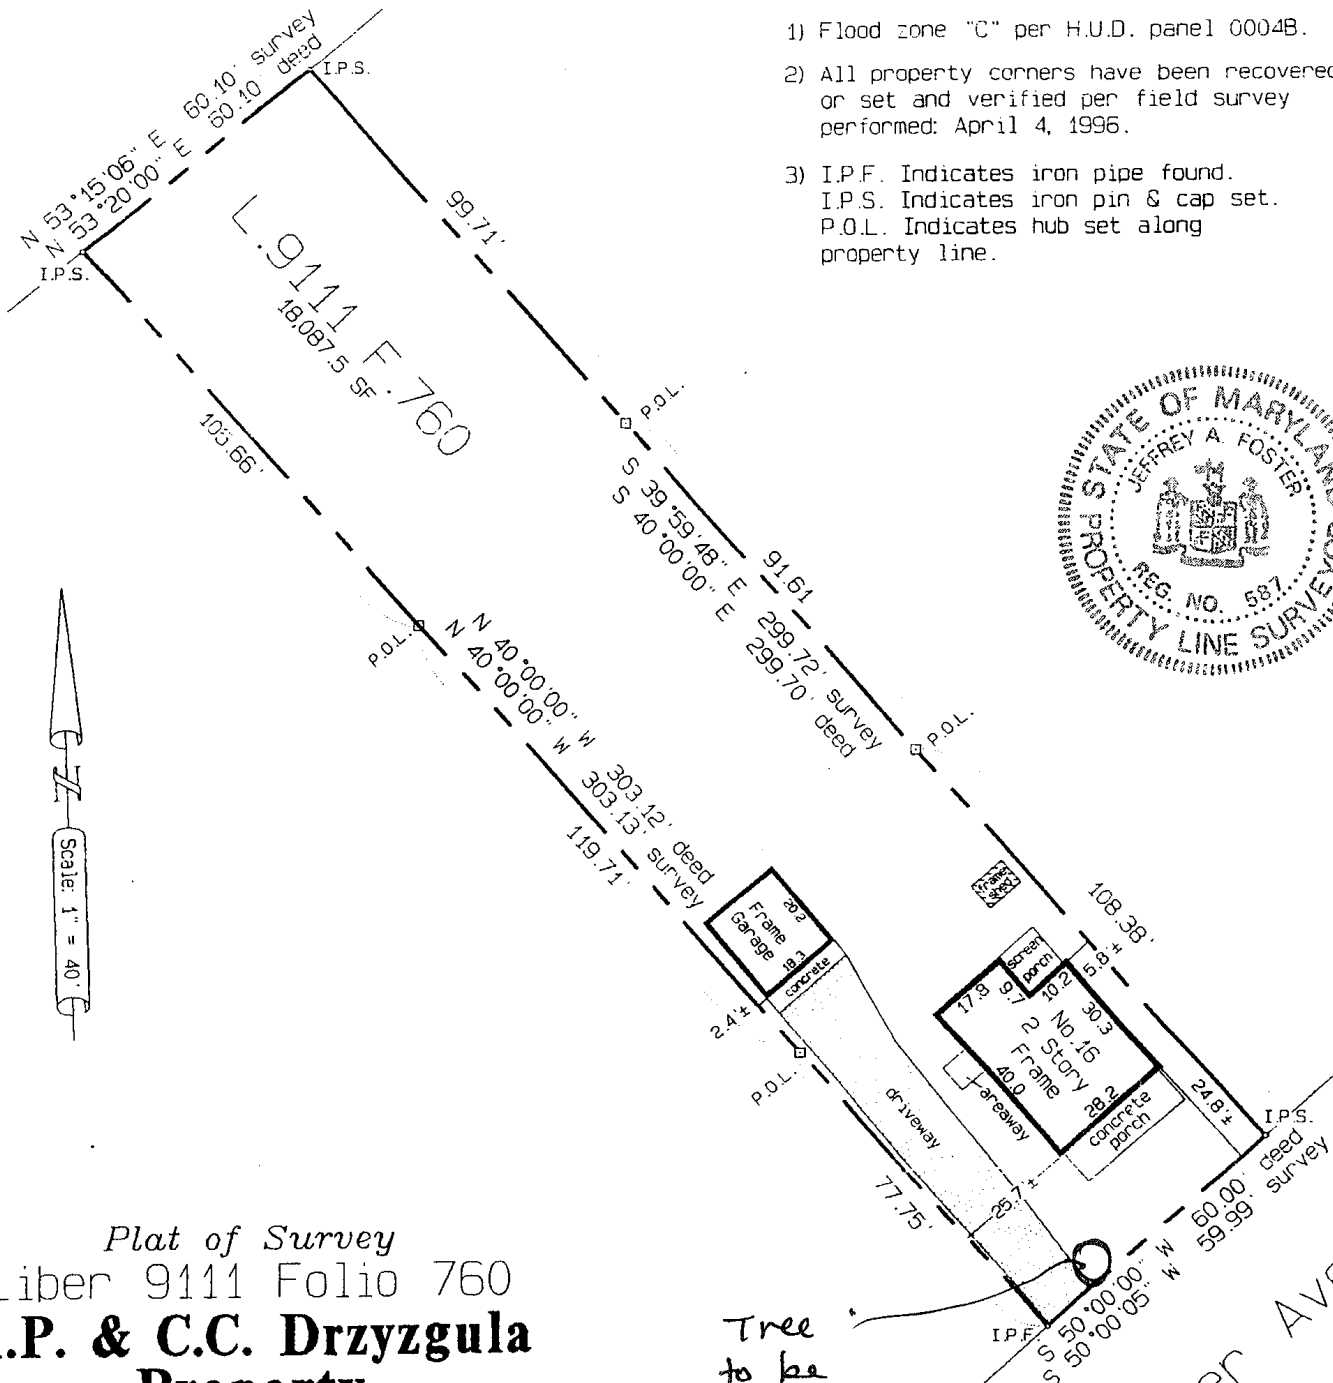
Plat of Survey  
 Liber 9111 Folio 760  
**R.P. & C.C. Drzyzgula**  
**Property**  
 City of Gaithersburg  
 Montgomery County, Maryland

Tree  
 to be  
 removed

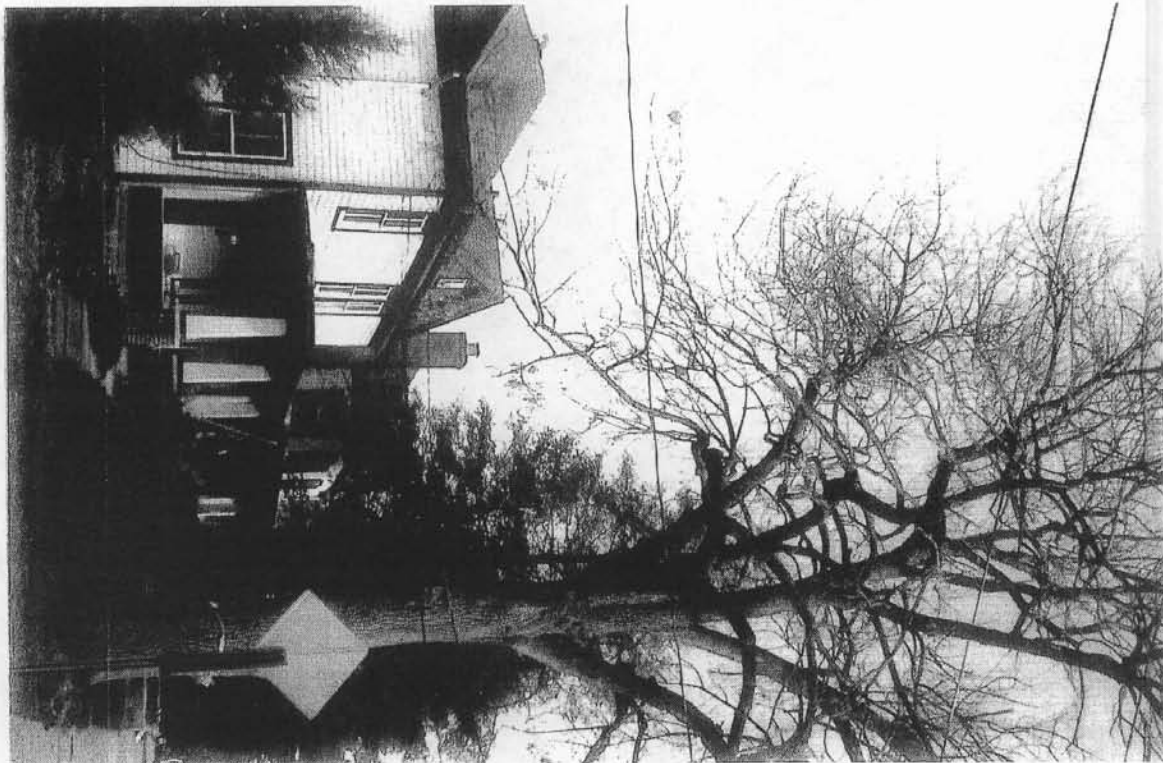
The applicants are requesting approval to remove a large ash tree from the front yard. The tree is failing at the root level and could pose as a hazard to the house.

View from Southwest

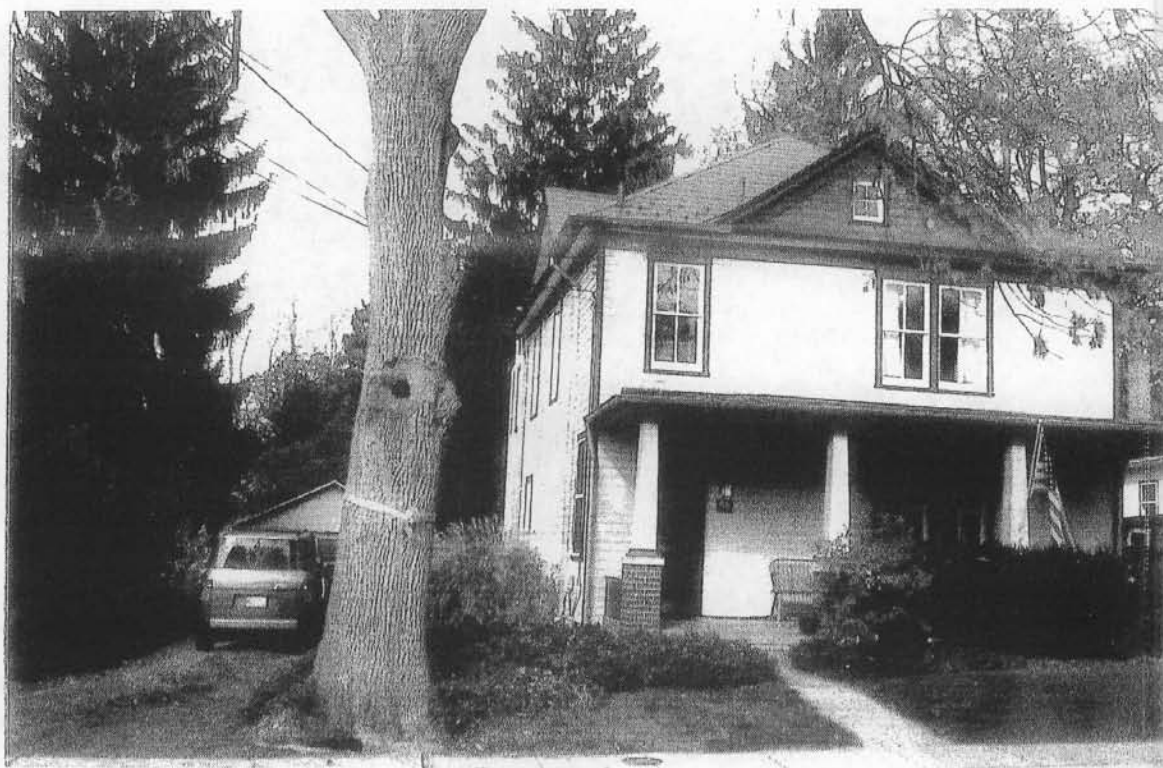
View from Southeast

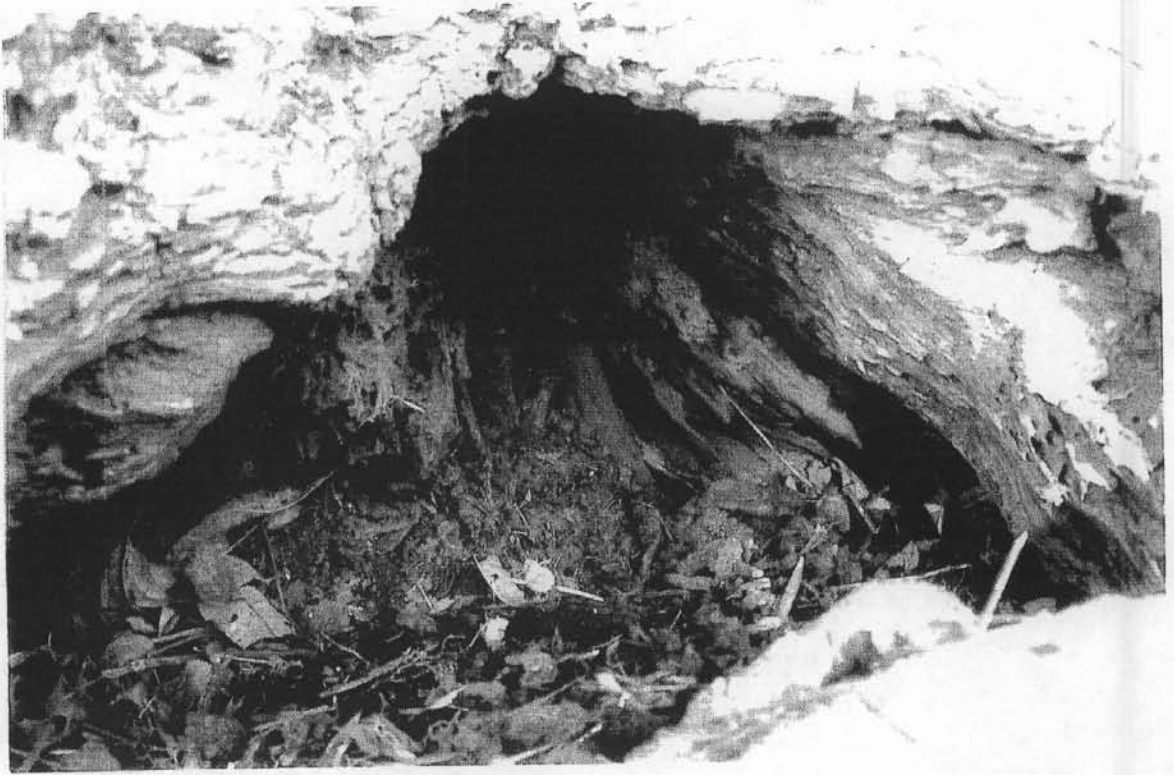
Unfortunately the evaluation also determined that there exists a high risk of the tree failing at the root level, as there are not enough roots on the street side, and one of the roots on that side is compromised by rot from below. There is a good size hole at the base of the tree next to the sidewalk, which has grown in size during the last year. The analysis concludes that the tree is likely to fall away from the weakly rooted side, which would cause it to land right on our house. There is a root in the driveway that now protrudes about 4" above the gravel level, this was not the case until a year or two ago, so I am concerned that the tree may already be shifting towards the house.

Closeup of cavity at base near sidewalk

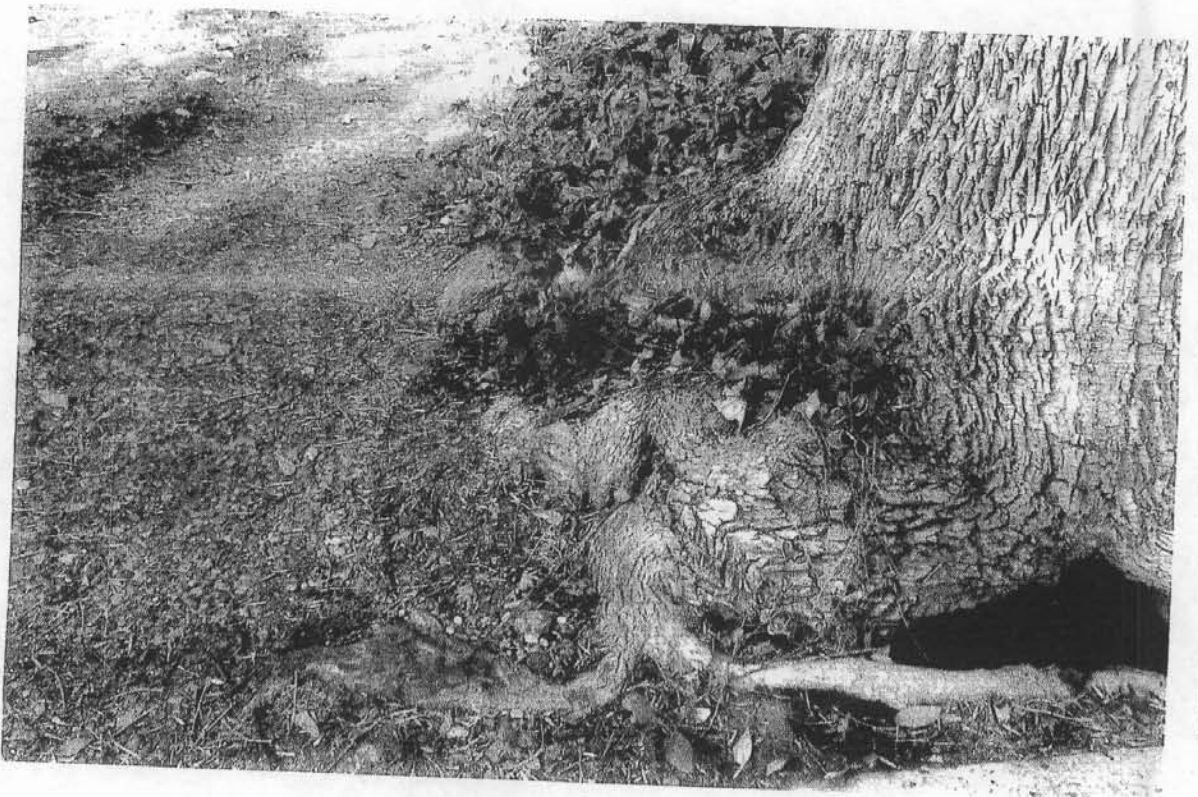
Cavity at base, and root raising in driveway.

Root(s)		
Structure	Arborist Risk Rating	Recommendations
Roots	High	Remove tree to eliminate the potential for failures
